Diagnostics of insulators Failures on Overhead Lines

P. Kučík, SlovCert, s.r.o., Bratislava, Slovak Republik**
T. Šmida, IBOK, a.s., Bratislava, Slovak Republik

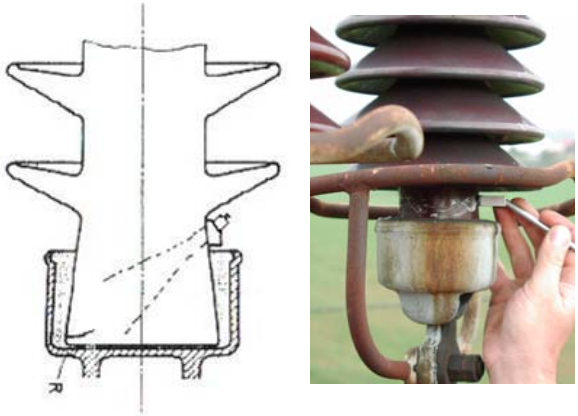
As the diagnostic system was developed the ultrasonic meassurement methode. This methode is not new and is known for manufacturer who have to tested quality of produced insulators. That means the ultrasonic testing was used mainly for new insulators.
The main task of this ultrasonic methode was testing and localization all defects or peripheral cracks under hanging metal armature as is describe on the picture (Fig. 8).

Figure 8. Schema of the using ultrasonic probe to detect transversal crack at head of the insulator and practical testing by angle beam probe
